**Balance  
Hydrologics, Inc.®**

January 20, 2014

**RE: Van Norden Dam Hydraulic Evaluation - CLIENT REVIEW DRAFT**

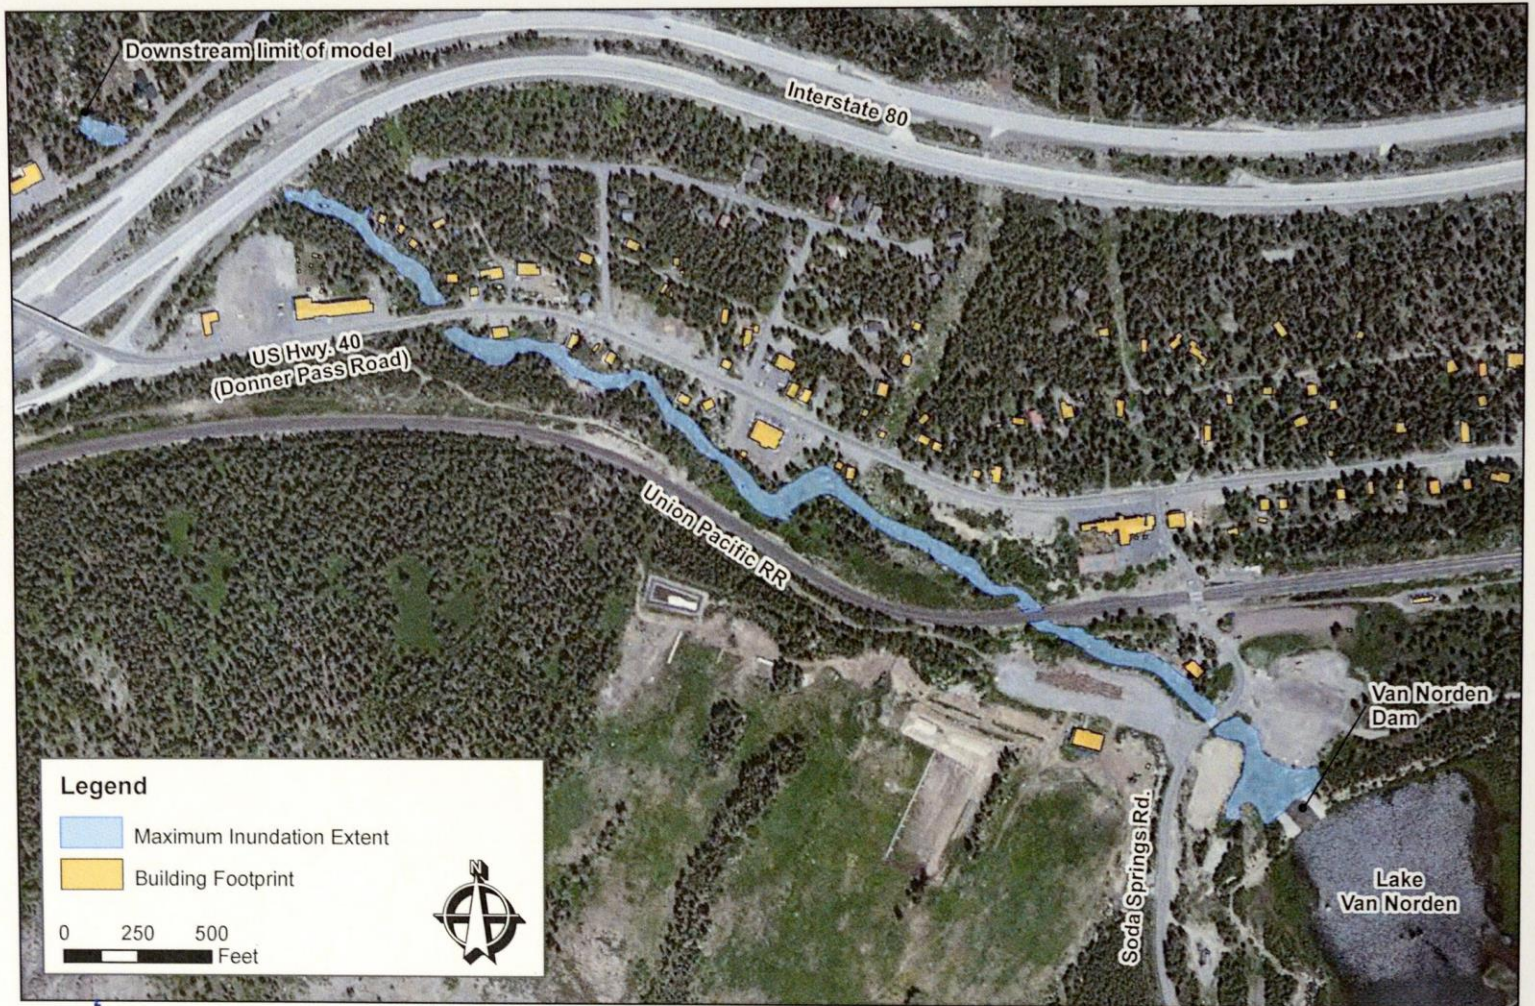
Figure 2 shows the inundation extents for the maximum stage during the sunny day breach. No structures are affected at the maximum stage for this event, nor is Soda Springs Road overtopped.

Figure 2. Maximum Inundation Extents for a Sunny Day Breach of Van Norden Dam, Peak Flow = 880 cfs  
South Yuba River, Placer and Nevada Counties, California

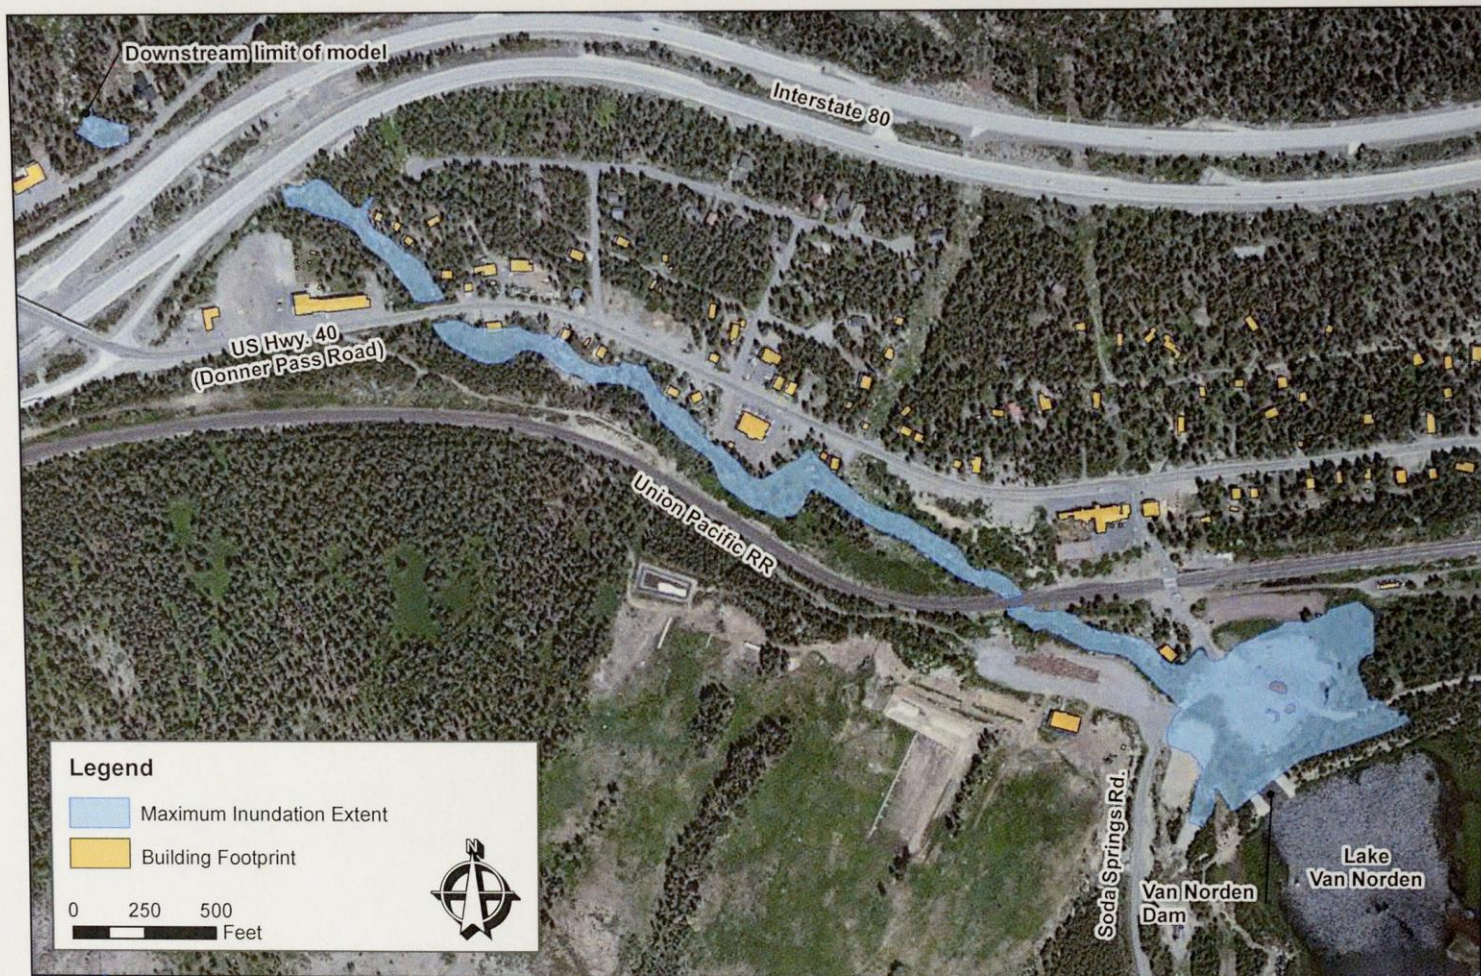
Figure 3 shows the inundation extents for the maximum stage during the design flood. A flood of 3,200 cfs has a modeled stage of 6,680.6 feet at the first home upstream of the Donner Pass Road culvert where the living floor elevation was estimated at 6680.7 feet. The only other structure inundated by a flood of this magnitude is the second home upstream of the Donner Pass Road culvert where the bottom 3.5 feet of the foundation—but not the living space—is wetted.

The Soda Springs Road bridge is overtopped at the design flood which causes a temporary economic disruption for the Serene Lakes community. A local resident confirmed that the bridge has overtopped four or five times in the last 50 years, and that there has been water three feet deep above the bridge deck following the largest events (Norman Sayler, personal communication, December 20, 2013). The bridge has not suffered damage in this time frame, so as soon as flood levels recede, the road is passable. Nevertheless, conveyance under the bridge is significantly less than the other three crossings within the study reach, and would be a good candidate for replacement regardless of the future configuration of Van Norden Dam.

Figure 3. Maximum Inundation Extents for the Design Flood (3,200 cfs)  
South Yuba River, Placer and Nevada Counties, California

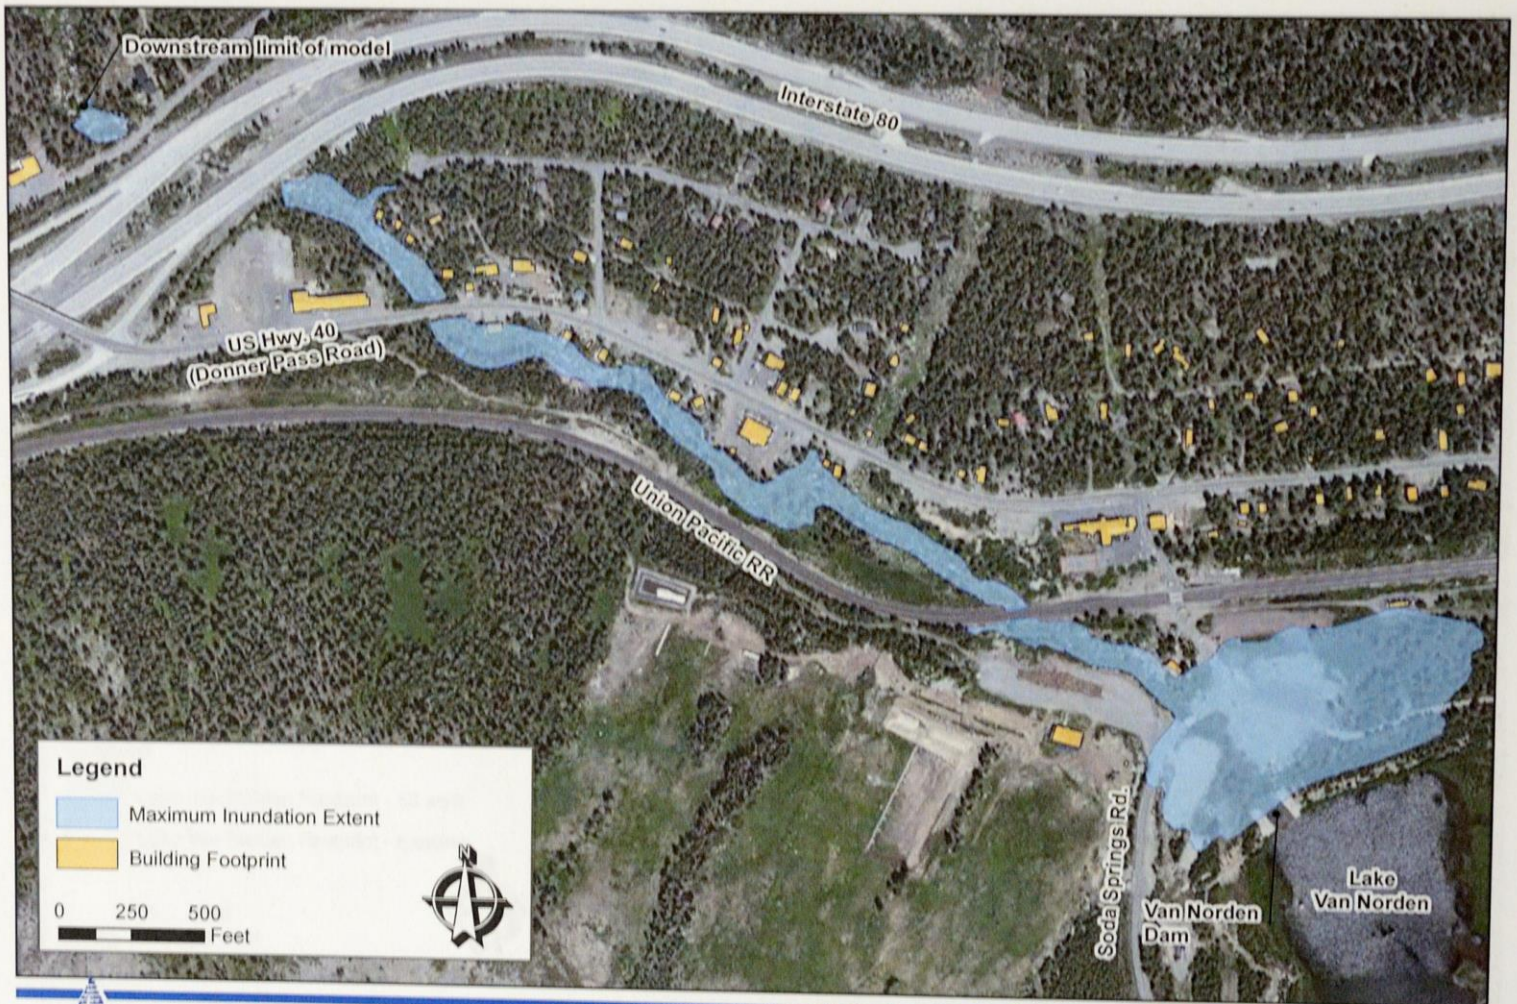
The peak of the outflow hydrograph for a dam breach concurrent with the design flood under the existing dam configuration is modeled to be 4,570 cfs; the maximum inundation extents for this scenario are shown in Figure 4. The incremental risk for this scenario (compared to the design flood with no dam breach) is the two homes mentioned in the design flood section have their living spaces inundated by several feet of water thereby threatening the lives of the residents. The level of inundation may be enough to threaten the structures themselves, however, modeled velocities in these locations are fairly low (less than three feet per second) making destruction of the homes by moving water unlikely. Flooding in these locations is directly related to backwater created by the Donner Pass Road culvert; backwater extended as far as 700 feet upstream during the simulation. The foundation of an additional home in the vicinity of the Soda Springs Road bridge is inundated in this scenario by less than one foot of water, but there are several feet of freeboard between the water surface and the living space.

**Figure 4. Maximum Inundation Extents for a Dam Breach of Van Norden Dam  
Concurrent with the Design Flood, Peak Flow = 4,570 cfs  
South Yuba River, Placer and Nevada Counties, California**

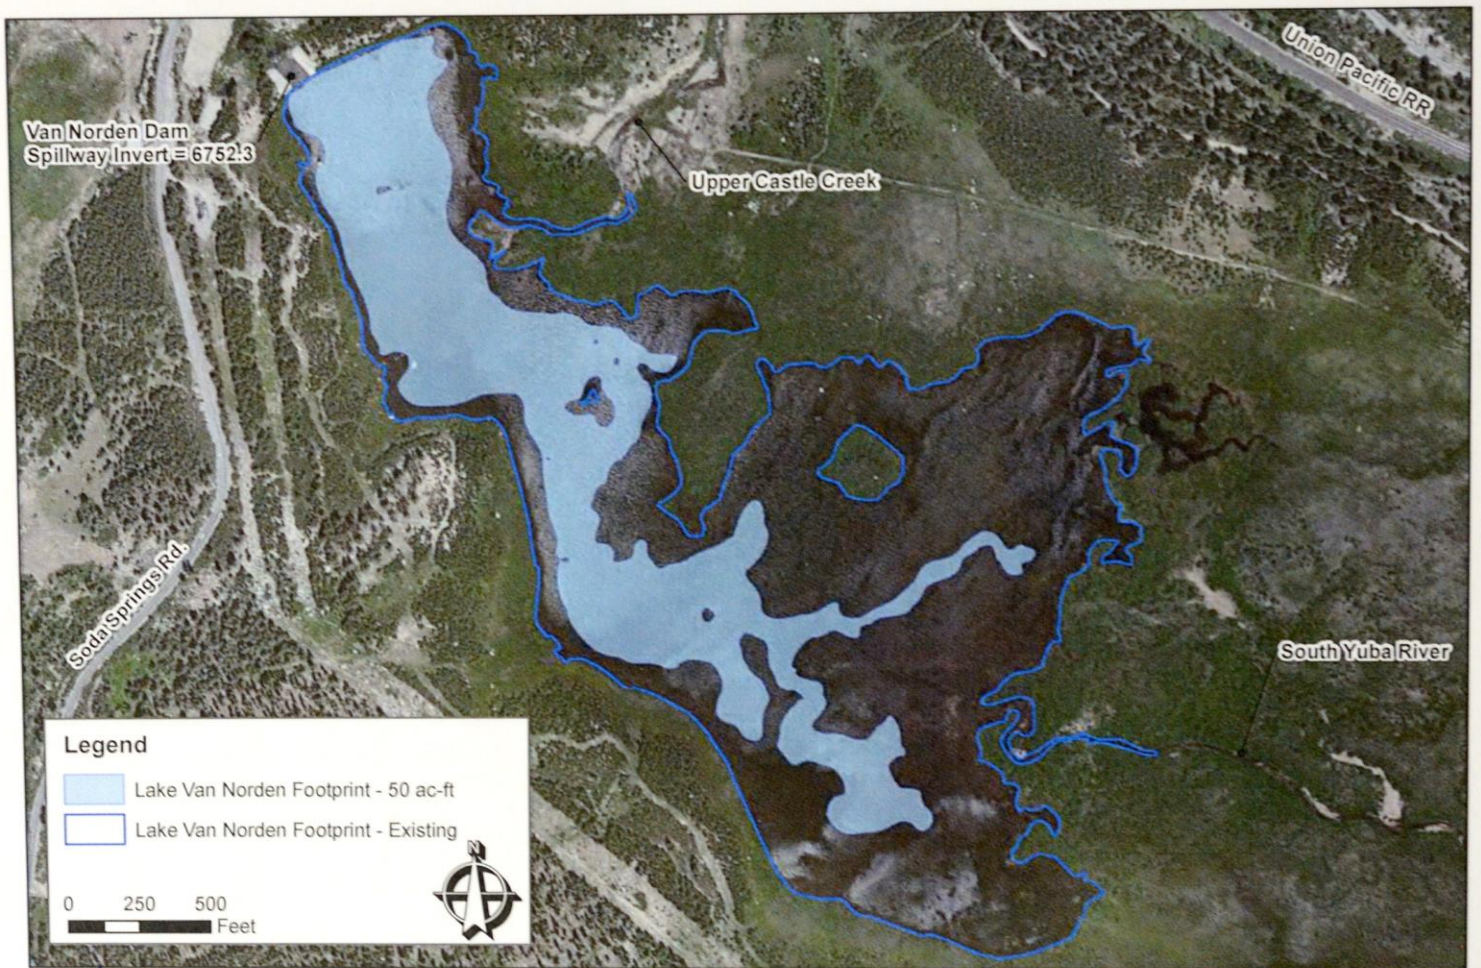
Lowering the spillway elevation to a level at which the dead storage in Lake Van Norden is less than 50 acre-feet has been identified by the Truckee Donner Land Trust and stakeholders as a viable alternative because (1) it would result in a non-jurisdictional designation for the dam, and (2) it is a compromise between having a lake and removing the dam entirely. Based on the bathymetric survey, the invert elevation of the spillway would need to be lowered by 2.3 feet to an elevation of 6,752.3 feet. The footprint of Lake Van Norden under this configuration is shown in Figure 5. A notched configuration for the spillway has been proposed where the spillway would function as a two-stage weir. The lower stage would have an invert of 6,752.3 feet thereby bringing the storage below 50 ac-ft, and the upper stage would have the same invert elevation of the existing spillway.

Figure 5. Lake Van Norden Footprint at 50 ac-ft of Storage  
Soda Springs, Placer and Nevada Counties, California

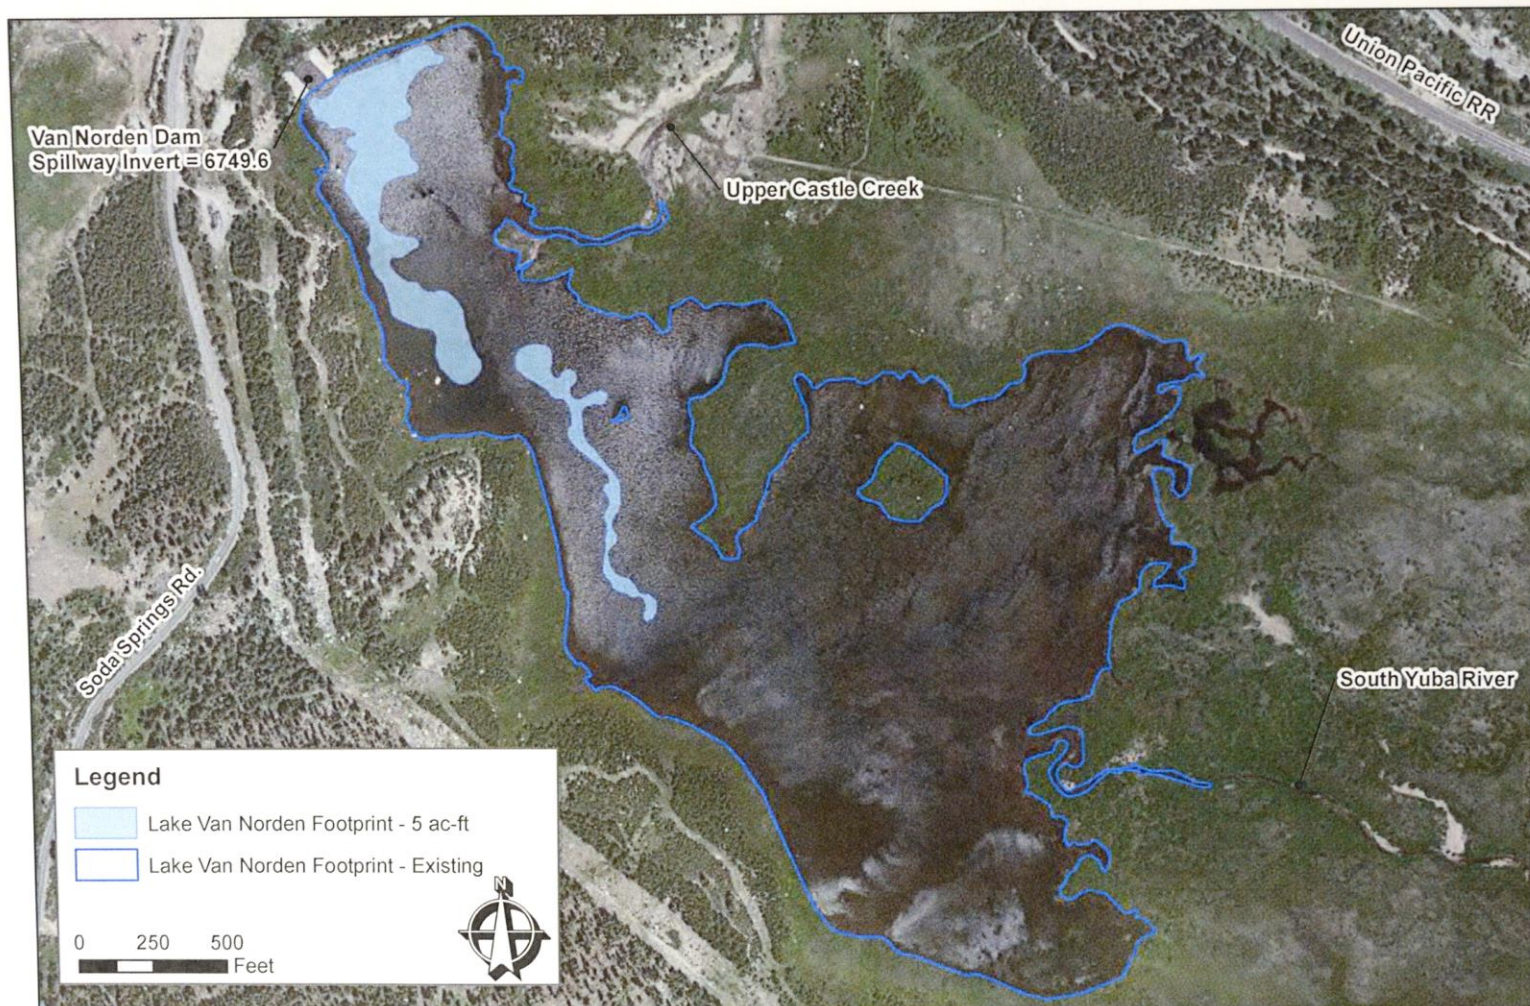
The threshold where no loss of life would occur was defined as the stage at which no living spaces are inundated. To achieve this condition during a dam breach event, the entire width of the spillway invert would need to be lowered by 3.3 feet to an elevation of 6,749.6 feet. Under this configuration, the dead storage in Lake Van Norden would be 5 ac-ft, and the lake footprint is shown in Figure 6. The peak discharge from a dam breach concurrent with the design flood would be 3,250 cfs, and the flood stage at the first home upstream of Donner Pass Road would be 6,680.8 feet. (The living floor elevation at the same structure was measured to be 6,680.7 feet.) We believe the additional 0.1 feet of flooding to be indistinguishable to loss of life and property, and within the level of error for the hydraulic model, especially since no data were available to calibrate the model. The height of the dam is lower in this configuration, and the ultimate breach width was adjusted accordingly to 10 feet. All other breach parameters remained unchanged. The possibility for property damage under this scenario is the same as for the design flood. A low hazard potential classification is recommended for this configuration; loss of life is highly improbable, and property damage would be minor, if any.

**Figure 6. Lake Van Norden Footprint at Low Hazard Rating Configuration,  
5 ac-ft of Storage  
Soda Springs, Placer and Nevada Counties, California**
