# Propane on Donner Summit – Part II

Blog post from OnTheSummit.net on 11/29/13

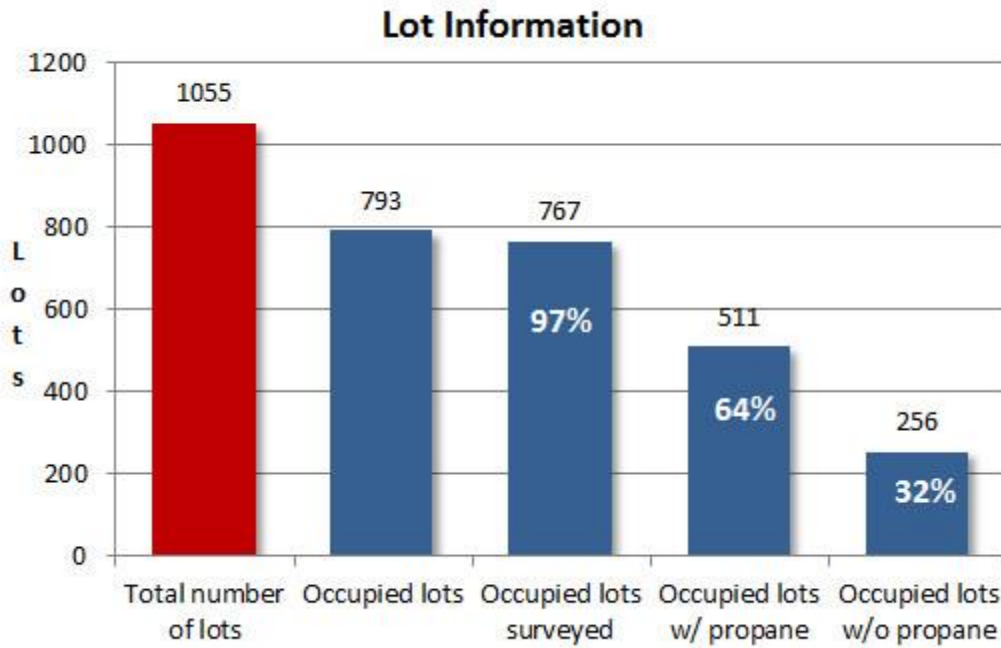
community. In Figure 2 the general usage of propane for each lot is presented. Approximately two thirds of the cabins in Serene Lakes currently use propane making it the overwhelming fuel source in the community.

Figure 2: General propane usage by lot. The percentages in white are for only the occupied cabins.

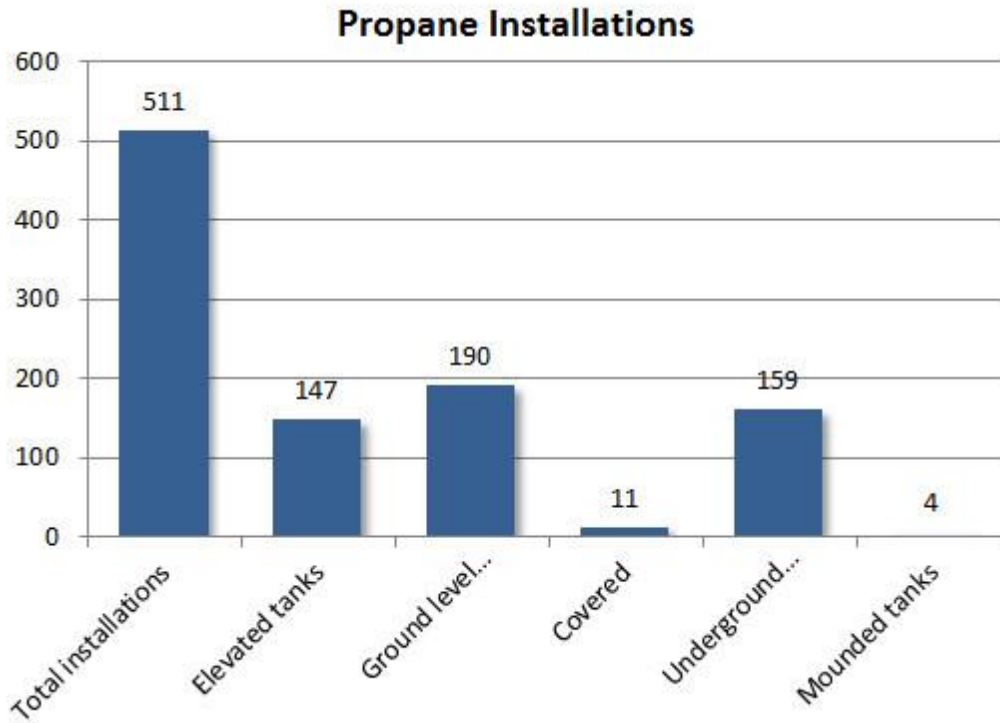
The prevalence of propane usage reinforces the need for implementation of safety standards and procedures in the current installations. The types of installations currently in use are shown in Figures 3 & 4. It is readily apparent that there is a variety of installation types being used in the community. The prevalent installation type used is an above-ground tank, either at ground level or elevated. While undergrounding or mounding of tanks has increased in recent years, the number of underground tanks is still only a third of the existing installations. A very small number of cabin owners have built a cover for their tanks, although there is no standard cover structure that has been approved for the area.

Figure 3: Propane installation types used in Serene Lakes

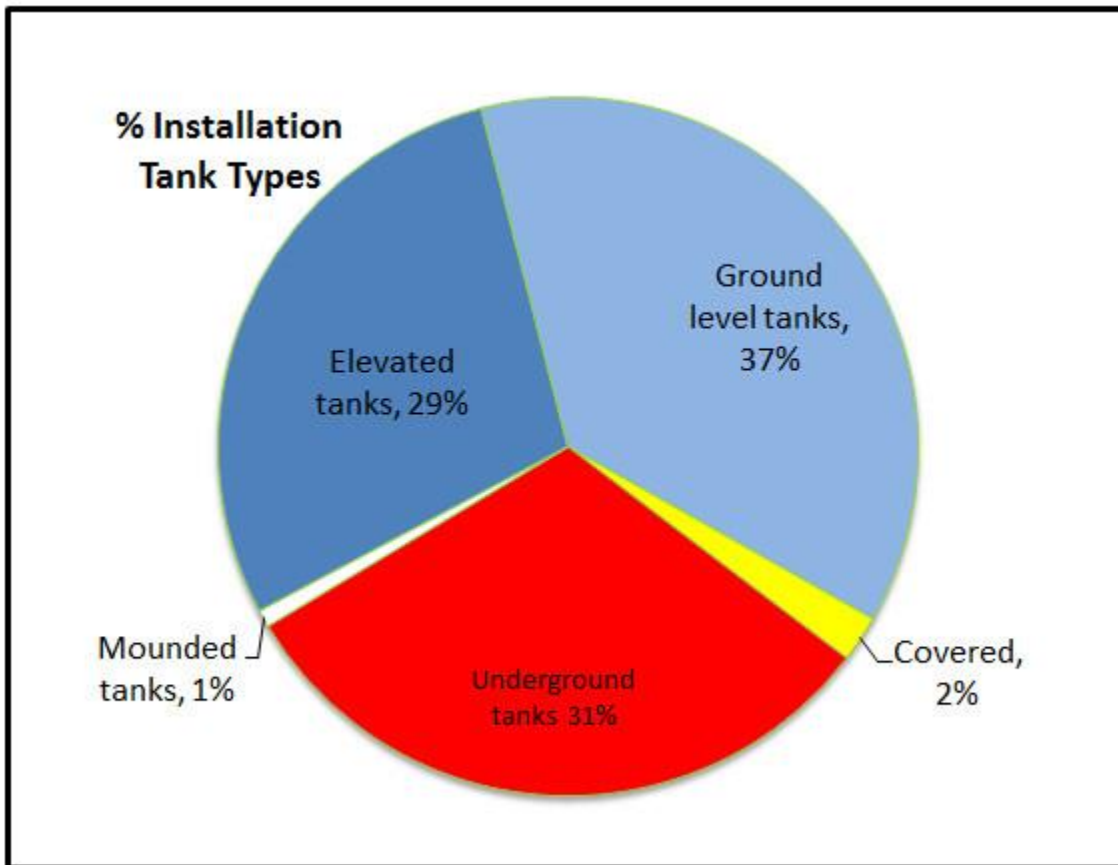
Figure 4: Percentage of each propane installation type in Serene Lakes

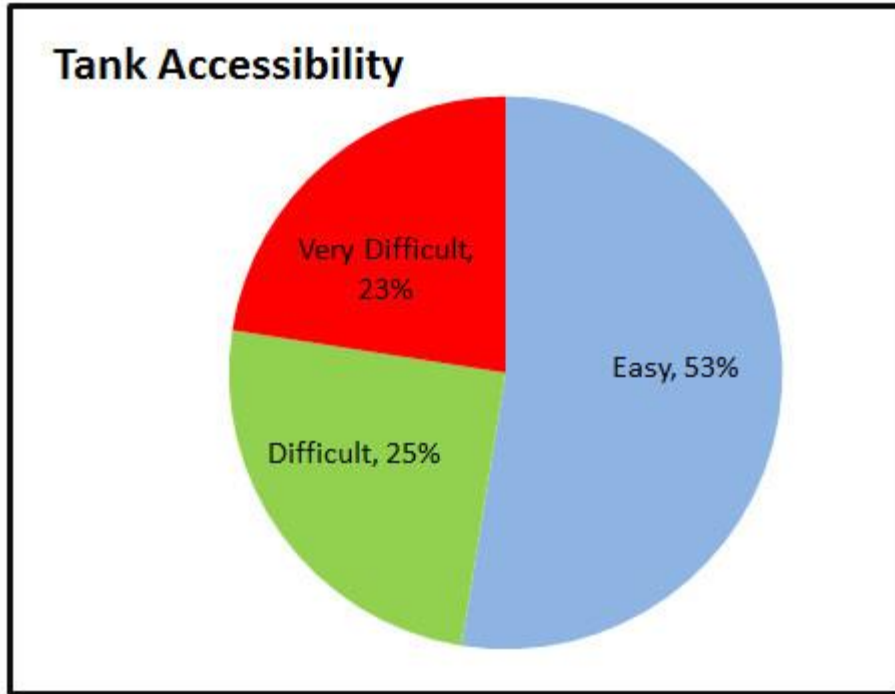
A serious concern for tank installations is the accessibility of the tanks in deep snow. Accessibility is determined by how far the tank is from an access point during the winter and thus how much deep snow must be dug out. Figure 5 shows the distribution of tanks by their accessibility. Categories of accessibility are; easy, tanks located 10 ft or less from an access point; difficult, tanks located 10-20 ft from an access point; very difficult, tanks more than 20 ft from

an access point. Realistically, only easily accessible tanks can be dug out by cabin owners on their own. The difficult tanks will require heavy equipment to dig them out in heavy snowfall. While a slight majority of the tanks are easily accessible, there are many tanks that are hard to get to and a significant number that are effectively lost during a big winter. The mandate that cabin owners should dig out their tanks may be plausible for many easily accessible tanks, but it is realistically impossible for many tank installations. It seems pretty disingenuous of the fire officials to mandate digging out all tanks when they were the ones that approved the locations of every tank in Serene Lakes, including the very difficult tanks.

Figure 5: Tank accessibility - easy <10ft, difficult 10-20 ft, very difficult > 20 ft

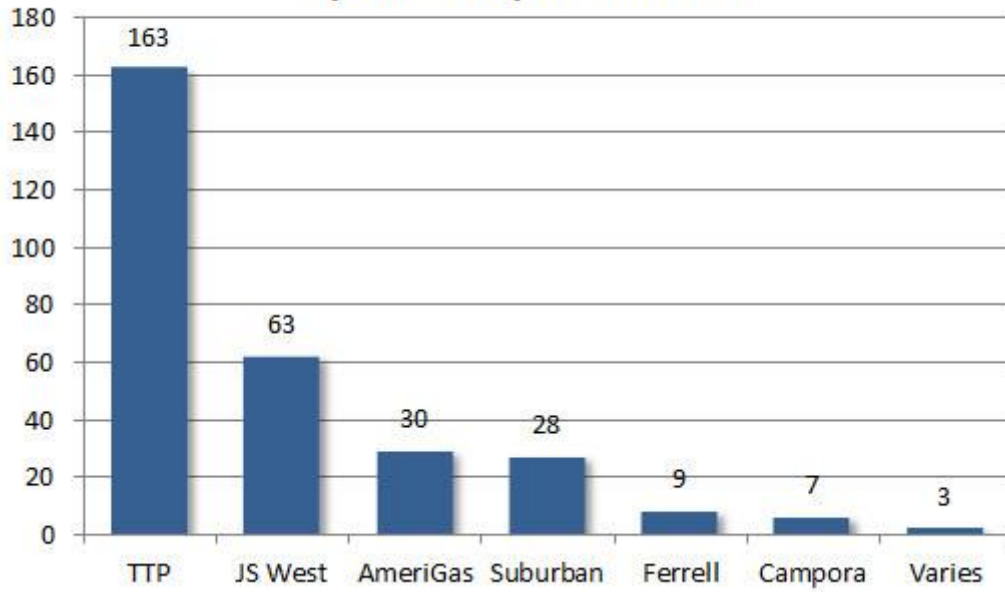
Currently there are six propane companies that supply propane to the summit. It is the propane companies that install and maintain the propane systems under the supervision of the fire department. As part of the survey for the directory, vendor information was gathered either from the installations directly or through online questionnaires directly to cabin owners. Vendor information for 303 (59%) of the cabins in Serene Lakes was gathered. The vendor information is shown in Figures 6 & 7. While the data is incomplete, it does show the trends for use of vendors by cabins in the area. It is clear from the data that Truckee-Tahoe Propane (TTP) is used by the majority of cabins (54%) in Serene Lakes with JS West, Amerigas and Suburban supplying the remaining cabins and Campora and Ferrell supplying a few cabins.

Figure 6: Vendor information reported for propane installations

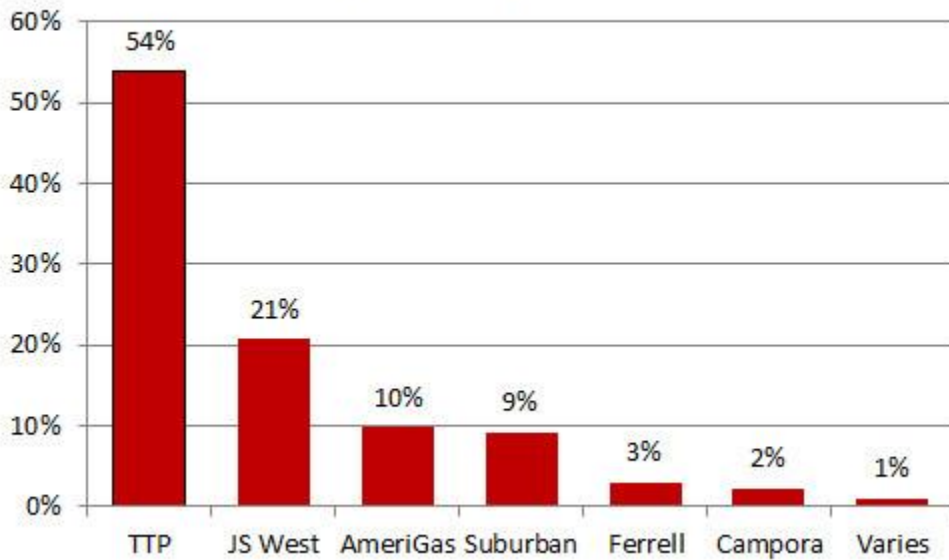
Figure 7: Percentages of vendor propane installations

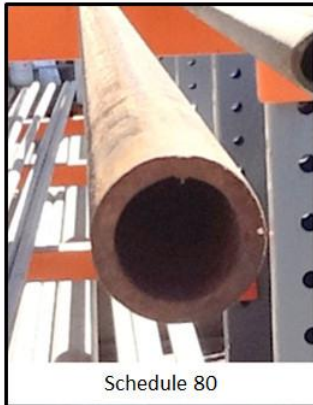
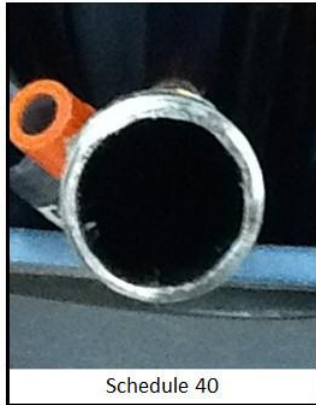
Cha, cha, changes!

During the summer Truckee Fire met with the vendors and mandated that they bring their systems up to code. This was not a trivial request because for all intents and purposes, all of the above ground tank installations were not up to code. This was because they were using schedule 40 pipe for at least the sweeper pipe coming out of the ground. Placer County code clearly specifies that the thicker and stronger schedule 80 pipe be used for the Serene Lakes area. While this code had been in place for at least 20 years, tanks were installed by vendors using schedule 40 pipe and approved by the fire department during this time. As a result almost every above ground tank in Serene Lakes needed to be upgraded. This was up to the vendors and the execution of these upgrades was very unevenly implemented between all the vendors.

Some vendors replaced all of the plumbing with schedule 80 pipe while others have either done nothing or just a portion of their installations. In the case of TTP, the largest vendor, they have installed flexible riser hose to replace the rigid pipe in many of their installations. This “flex-line” is used in many high elevation areas because it prevents the breakage of rigid pipe due to tank movement from snow. In fact, Nevada County approves the use of this line for their portion of the summit. At the writing of this article however, Truckee Fire has not approved this flex-line because Placer County code specifies schedule 80 rigid pipe.

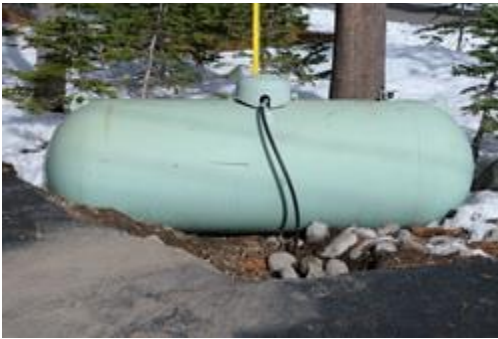
*Tank with flex line*

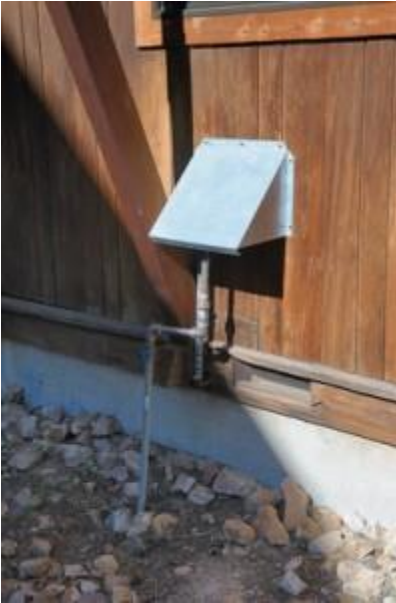
*Covered regulator*

As explained in [Part I](#) of this article, the propane supply line coming from the tank connects to a second stage regulator where it enters a cabin. This regulator reduces the gas pressure to approximately .4 psi for use by interior gas appliances such as stoves and furnaces and also acts as a backup in case the first stage regulator malfunctions. In many ways the secondary regulator can be the most vulnerable and dangerous part of the system. Because it is very close to the cabin, a leak in the plumbing at this stage has the potential for leakage of gas into the structure where it can pool and be exposed to ignition sources within the home with possible catastrophic consequences. It is also possible for the regulator mechanisms to be damaged by ice so that over-pressurized gas is fed into the home which can cause leakage at appliances within the home. [Placer County](#) code requires that the secondary regulator be covered to shield it from the force of the snow.

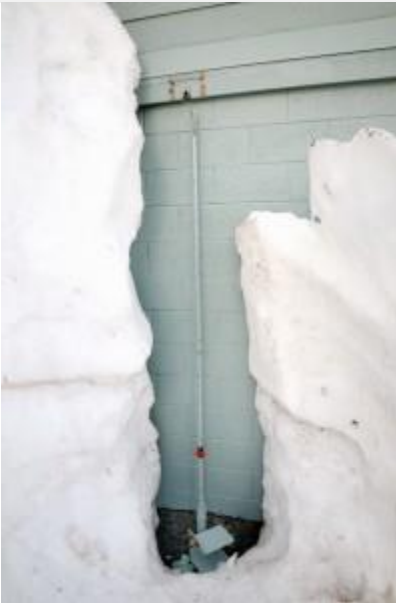
*Broken secondary regulator*

In the course of mapping the secondary regulator positions for the propane directory, it became apparent that while the large majority of cabins do protect the regulators, there are a significant number of cabins that have inadequate or no protection for these regulators. Figure 8 shows an exposed regulator that was broken off last winter at a cabin by high snow and ice moving along the exterior of the cabin. This caused a significant leak in the community. These regulators are currently rated for 15 years of usable life and should then be replaced by the vendor (many vendors replace them every 10 years). Clearly many of the regulators observed in the survey looked older than 15 years . While there has been a lot of attention paid to tank installation and maintenance, there seems to be much less attention paid to the secondary regulators, which may in fact be a much bigger problem. There appears to be no standard for where the regulator should be placed on the home and in many cases it is placed so that it would be

almost impossible to get to the regulator and shut off valve in a heavy snowfall condition. Secondary regulator safety is definitely a problem at many cabins and it needs to be addressed.
